Studio di una frana in terreni strutturalmente complessi: interazione con le opere di imbocco di una galleria stradale *Curriculum: Ingegneria dei materiali, delle acque e dei terreni*

Abstract. During the construction of the south portal of the tunnel Baldaia I along the SS106 motorway in Calabria, unexpectedly large and continuous displacements of the earth retaining structures occurred leading to a precautionary suspension of the excavation works. To study the kinematics of the observed instability phenomenon, inclinometer probes were used together with the topographic monitoring of the portal structures; it was found that the unstable mechanism was deep-seated, block-type and extending over the entire slope. In this paper the site investigation activities carried out to understand the origin of the instability process are presented. The interpretation of the observed behaviour is then given together with the description of the remedial measures suggested to safely complete the construction of the tunnel. The link between the time evolution of the instability and the sequence of the excavation works, which turned out to be an important issue in the process, is also discussed in

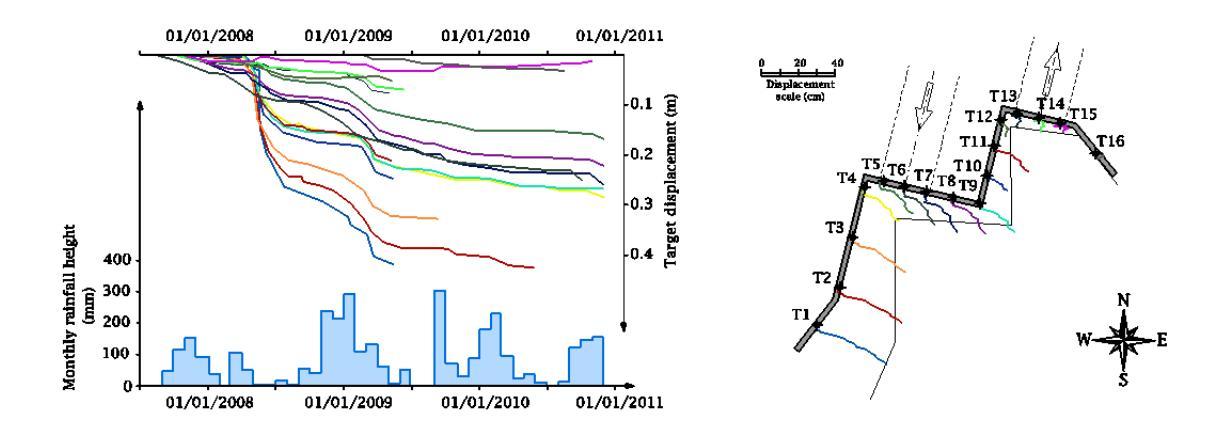
The observed trend from the targets indicates that the slide activated after the completion of the portal excavation, when the second level of anchors was fully installed. This is shown in Figure 2 by the rapid increase of the displacements in May 2008 when the tunnel face was still 150 m behind the portal. After a first acceleration, the displacement rate decreased during the following summer (from July to September) and then increased again at the end of November during a heavy rainfall period. In particular, the displacement patterns for targets T1, T2 and T3 show that a failure stage was reached. After these events the third level of anchors was also completed, but a significant decrease of the displacement rate for the targets could only be obtained with the earth refilling of the excavated area.

Figure 2 Top beam target displacements and monthly rainfalls during the portal construction (left); XY displacement patterns of the targets (right).

This remedial measure proved to be effective although a displacement increase is still observed especially during heavy rainfall periods. Meanwhile, the downslope Northbound carriageway was completed and the Southbound tunnel face was brought to about 30 m from the portal, close to the edges of the prospected slope instability mechanism. The XY displacement patterns of the portal top beam targets shown in Fig. 2 are characterized by a twofold trend:

- a rigid translation along the strata dip direction;
- a rigid rotation about the north carriageway portal.

A closer look at the displacement vs. time graph (Fig. 2) shows the tendency of displacements to accelerate during periods of heavy rain. This fact, together with the established presence of open tension cracks, suggests the hypothesis that the cleft pressure exerted by water penetration into the open fissures may act as the triggering external force.

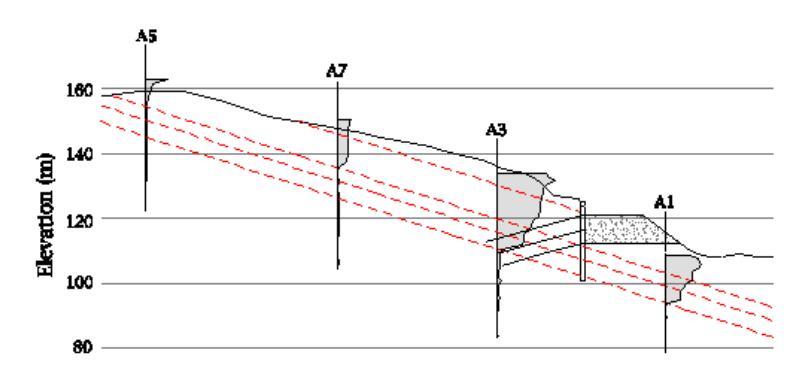
Inclinometer profiles are shown in Fig. 3. The presence of multiple sliding mechanisms is evident, coherently with the bedding at different depths and along the slope.

Figure 3 Inclinometer readings along the bedding planes' dip direction (S-S).

A comparison between displacement measurements from the targets and inclinometer profiles revealed how the slipping rate is governed by the deep seated surface running below the portal structures. In this sense, the Baldaia landslide may be defined as a composite landslide with the superimposition of a shallow earthflow downslope (in the first 4 m) and of three nested block-type failure mechanisms the deeper of which is located at a depth of 23 m from the surface.

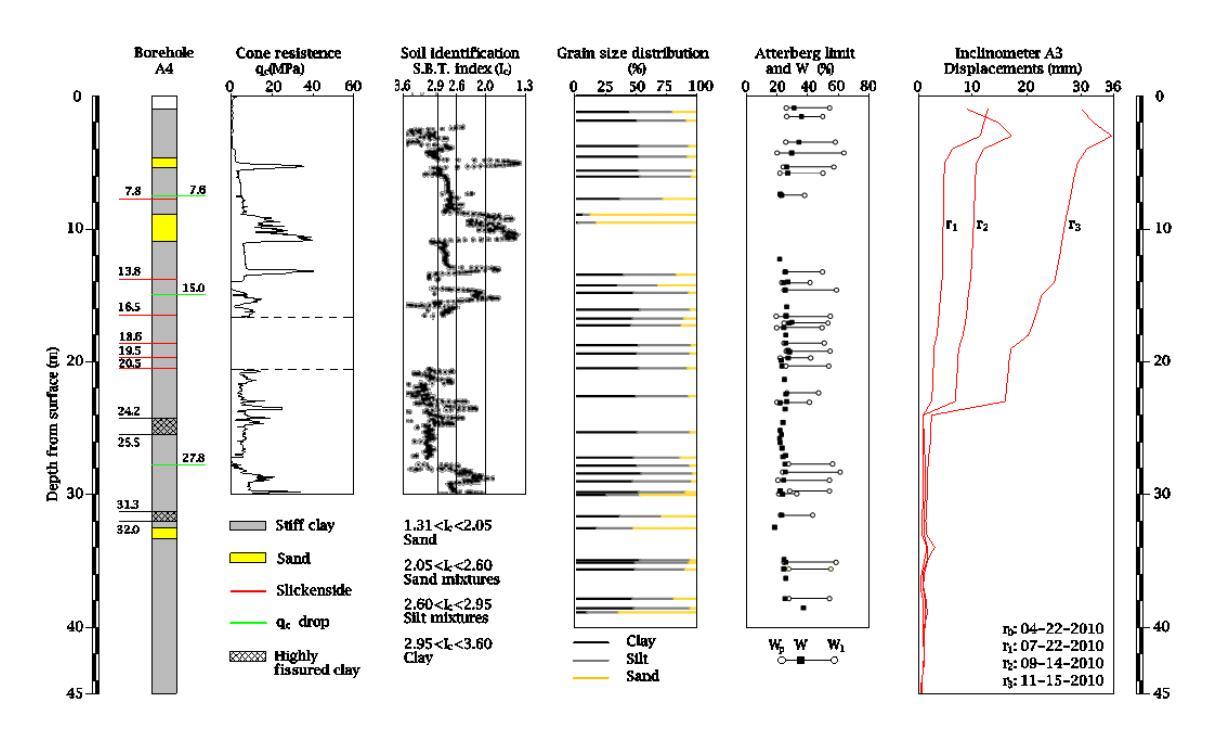
The soil stratigraphy is well represented by a typical borehole log in Fig. 4; within the investigated depth of 45 m it appears characterized by the diffuse presence of the overconsolidated clay formation that is however interlaid by three sandy layers which were recovered at depths of 3, 10 and 32 meters from the top. CPTu profiles are also shown in Fig. 4. These profiles are very useful to detect shear planes, through a drop of both the point resistance and of the driving induced pore water pressure increment. Despite the lenticular nature of the depositional environment, the interlaid sandy layers appeared continuous at the slope scale (Fig. 5).

Figure 4 Overlap of data collected at the A4 borehole and the readings of the corresponding A3 inclinometer.

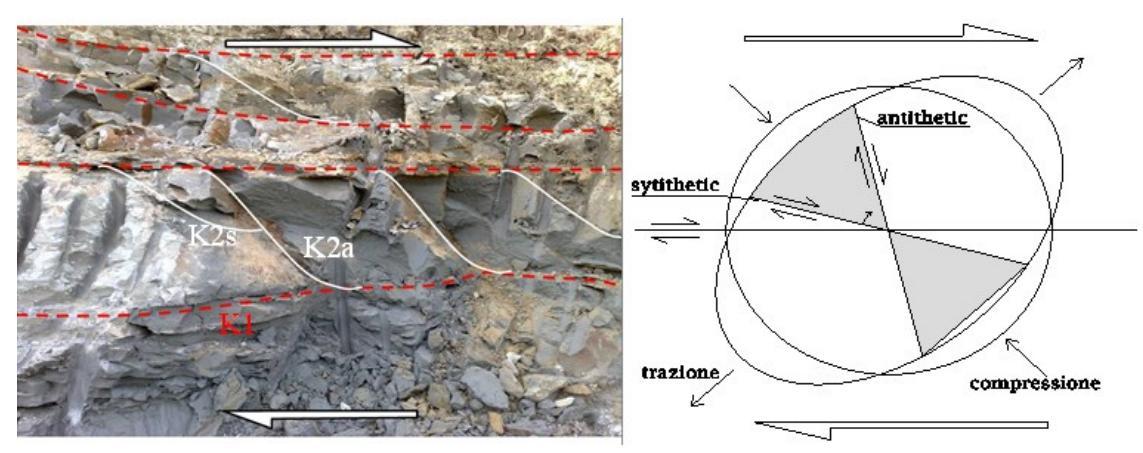
Discontinuity characterization was carried out on different outcrops located close to the site, the main of which are above the portal and between the two carriageways. The excavated surfaces showed the frequent presence of shear bands, typical of ductile shear zones. The observed macro-structures are shown in Fig. 6 and may be interpreted as bedding planes (K1) and Riedel-type extensional shear planes (K2). Riedel shear zones typically develop as sets of conjugate second-order discontinuities in response to the stresses associated with a first-order failure in simple shear.

These structures develop at a late stage of the shearing, well after the reorientation of the minerals along the shear surface has occurred. The Riedel shear surfaces are confined between the bedding planes, exhibiting the typical S-shape within the clay layers. Only occasionally do the discontinuities cross minor sandy strata developing between the main bedding layers.

Figure 6 Riedel shear bands (white) and bedding planes (red).

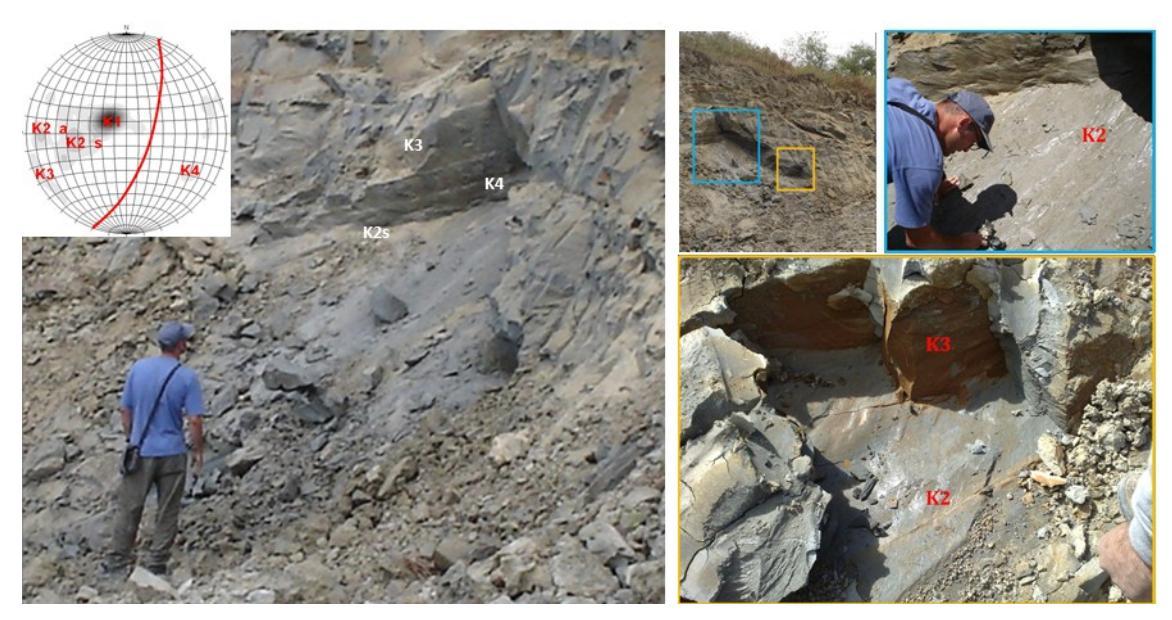
The outcrop between the two carriageways exhibited a slight clockwise rotation and steepening of the K1 and K2 discontinuity sets. The former rotation may be related to the presence of a fault dislocating a 50 cm thick sand layer. The fault orientation, also observed during the excavation of the tunnel for the North carriageway, is consistent with the K4 joint family and constitutes a kinematically favourable closure plane for the main block failure. During the main outcrop cleaning operations some small blocks broke off along K3 and K4 joints, slipping in a plane-type mode along the Riedel "synthetic" shear planes K2s (Fig. 7).

At a slightly bigger scale, the whole outcrop face (10 m large and 4 m high) became later unstable, sliding along the bedding plane K1; again, K2 and K3 open tension cracks were observable 25 m uphill; the nearby inclinometer detected displacements at a depth of 5 m.

Figure 7 Different scale block detachments at the main outcrop.

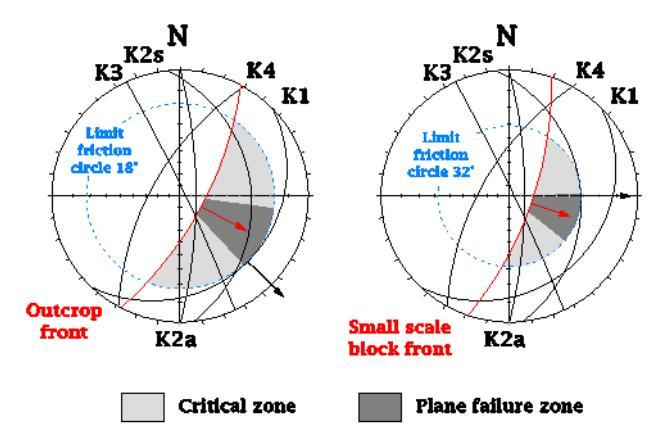
Both these observed plane-type phenomena are kinematically allowable, according to the plane failure condition suggested by Hoek & Bray (1981), on the Markland test plot (Markland, 1972, Fig. 8) although their occurrence requires a friction angle along the sliding surface less than 32° for K2s plane and 18° for K1 bedding planes.

Figure 8 Stability condition on outcrop front and small scale block front.

friction angle equal or less than 18°. Therefore an external force is needed for the instability to happen.

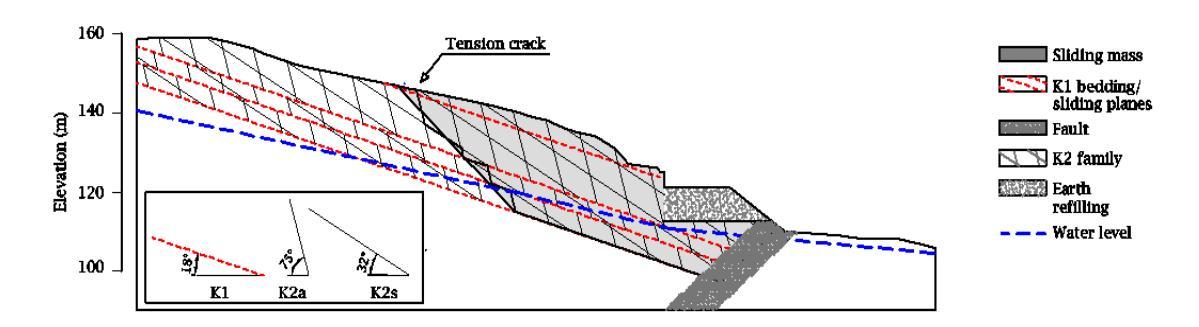
Figure 9 Proposed geotechnical model.

The unstable soil mass is thus bordered by a K1 plane, a traction K2 surface and a closing fault surface. Being the mass stability strictly related to shear strength along the discontinuities, a number of shear tests were carried out on samples containing either pre-existing discontinuities or artificially created sliding planes. Direct shear tests on 6x6 cm samples were conducted with the sliding parallel to the surfaces at a displacement rate of 1 x 10⁻³ mm/min. The residual strength was determined using three different procedures:

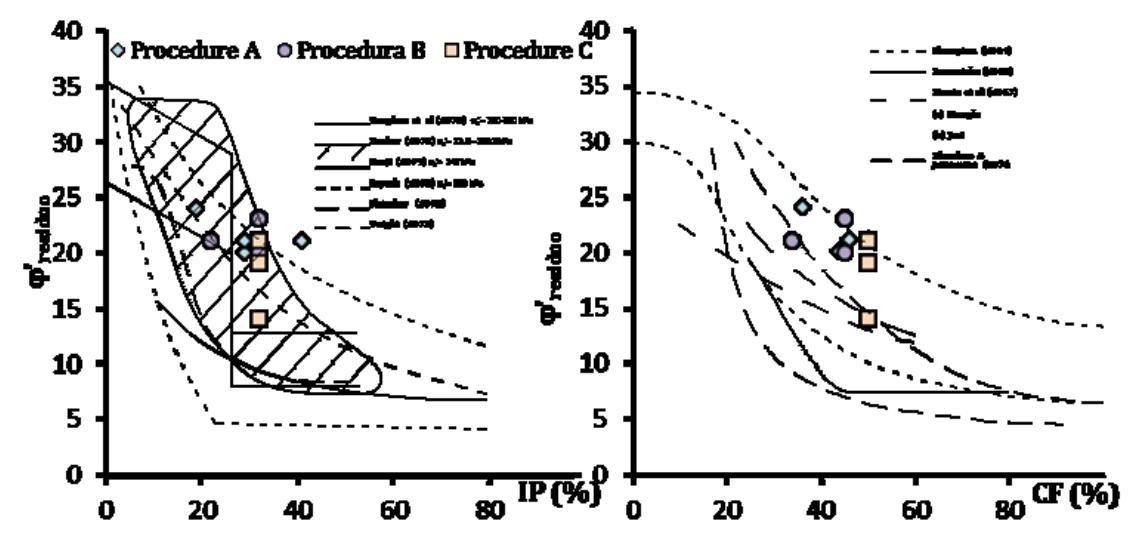
Figure 10 Summary of the residual shear tests results (after Lupini et al., 1981)

Regardless of the shearing procedure, the residual friction angle always resulted close to 20°. This value is coherent with the values of residual angle that can be inferred from classical correlations, for plasticity index (Ip) values between 20 and 30.

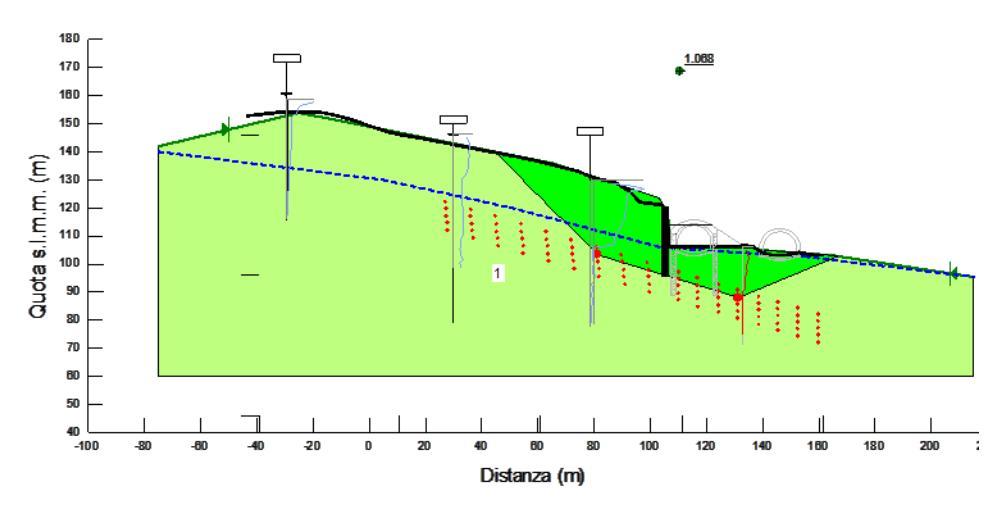
The stability analysis based on the limit equilibrium method show security factors slightly higher than the unity in the configuration corresponding to the end of the excavation works.

Figure 11 Sliding surface configuration at the end of the excavation

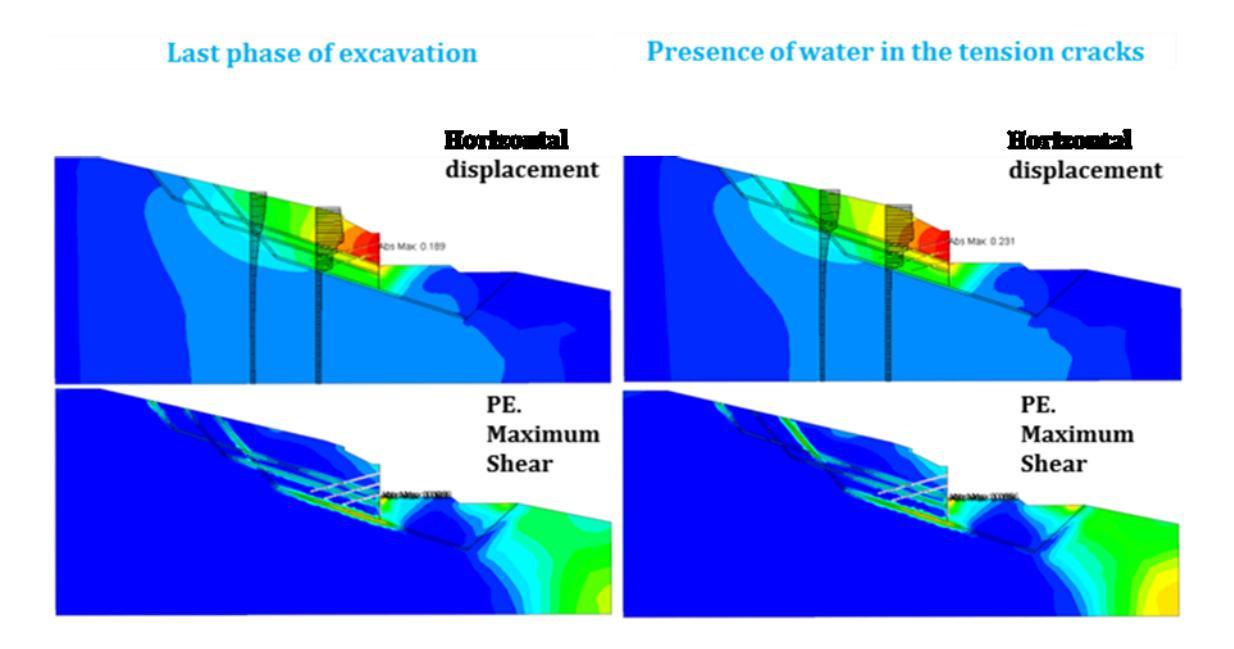
The 2D finite element analysis deformations fit the inclinometric observations, in terms of both shape and extent (block-type movement). The results of numerical analysis show also that the presence of water in the tension cracks could activate a further block located upward (secondary block) (Fig.13).

Figure 13: Main phases of the 2D modeling.

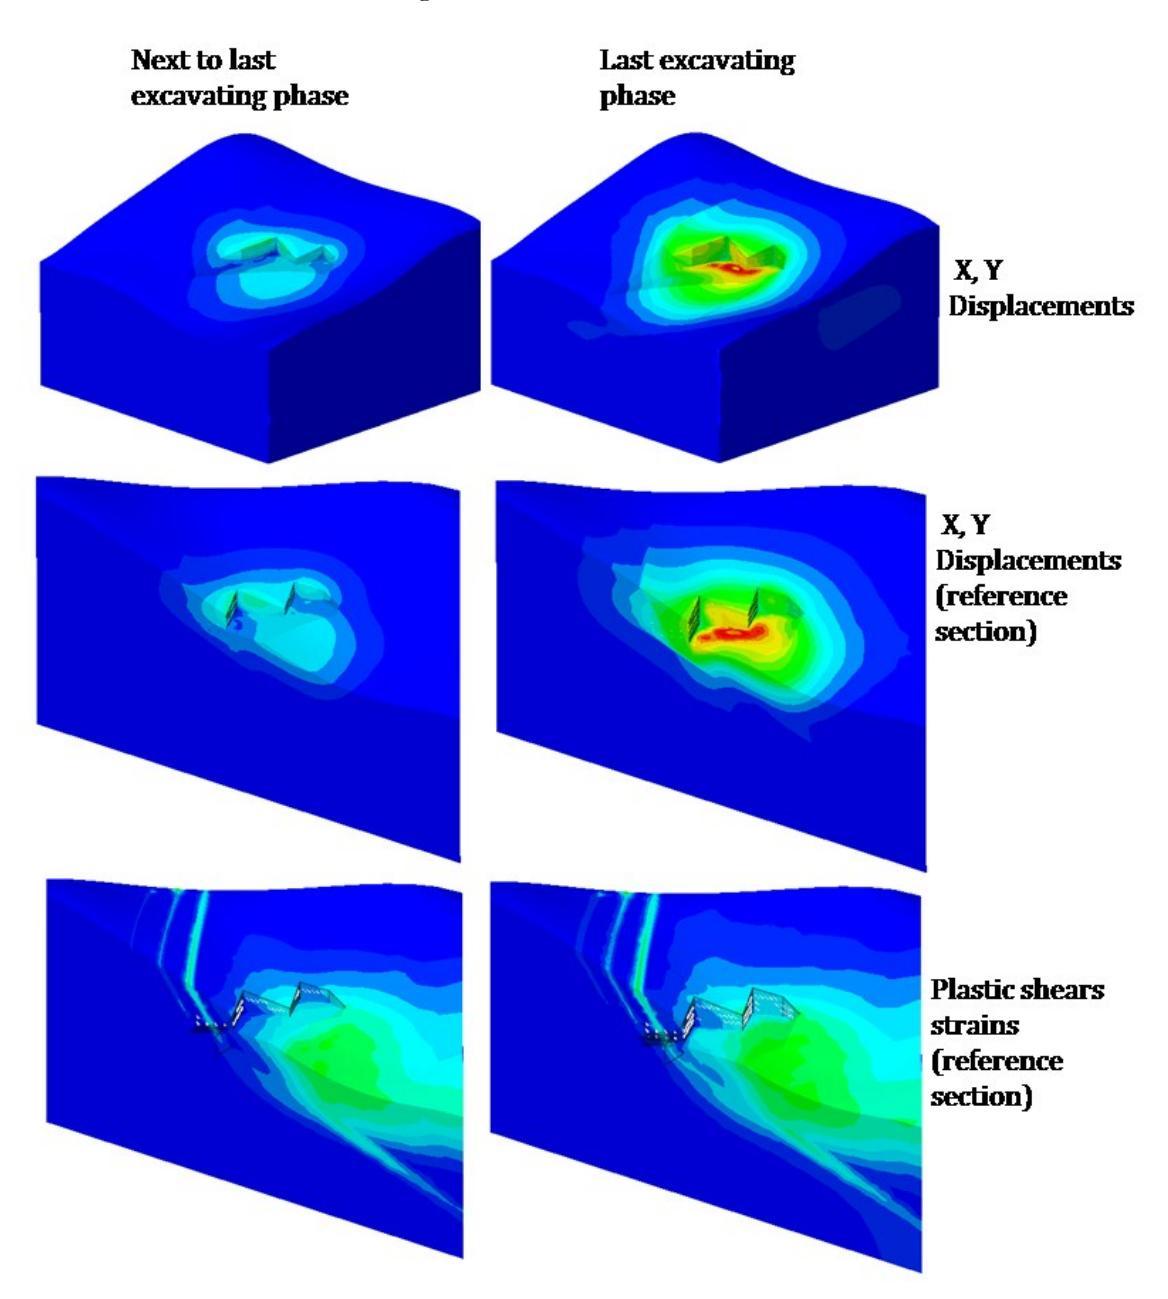
The 3D modelling substantially confirms the results of the 2D modelling, as shown in fig. 14.

Figure 14 Main phases of the 3D modeling.

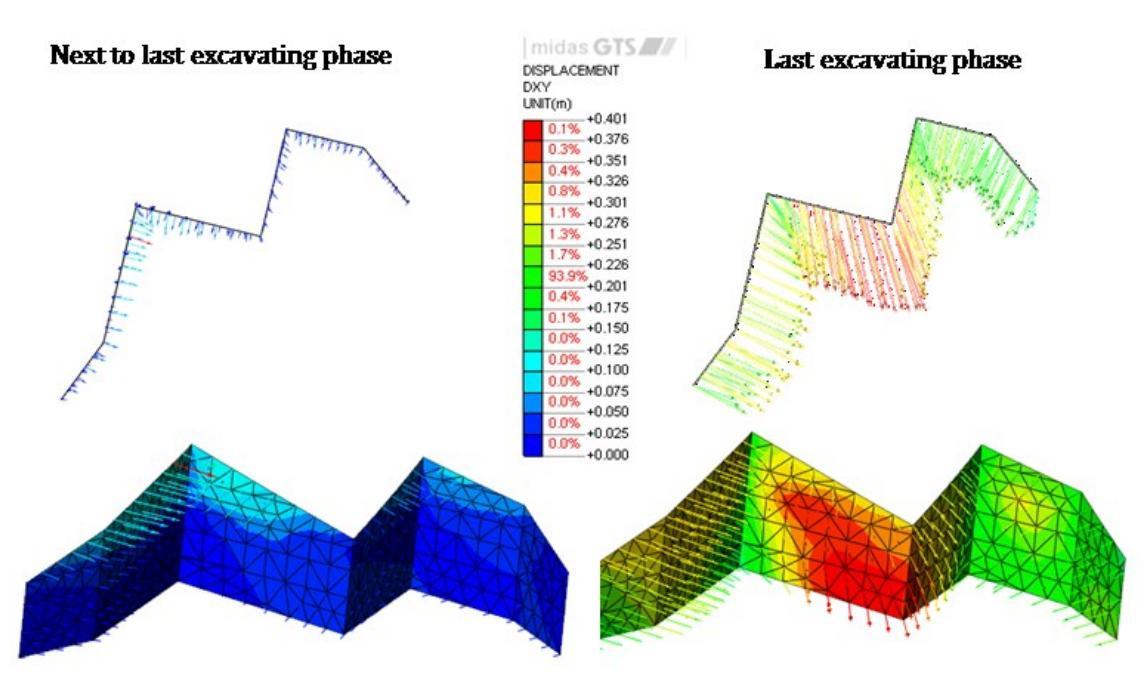
The tridimensional analysis make possible to read the evolution, in terms of main direction, of the displacements of the portal structure (Fig.15). Except for the last excavating phase, the displacement directions are perpendicular to the portal, while in the last phase corresponding to the maximum excavation quote, the whole portal moves along the maximum slope direction (135° to the North). A rigid translation of the principal block on a K1 joint is evident on the 3D model of figure 14.

Figure 15 Displacement of the portal in the last two phases of excavation.

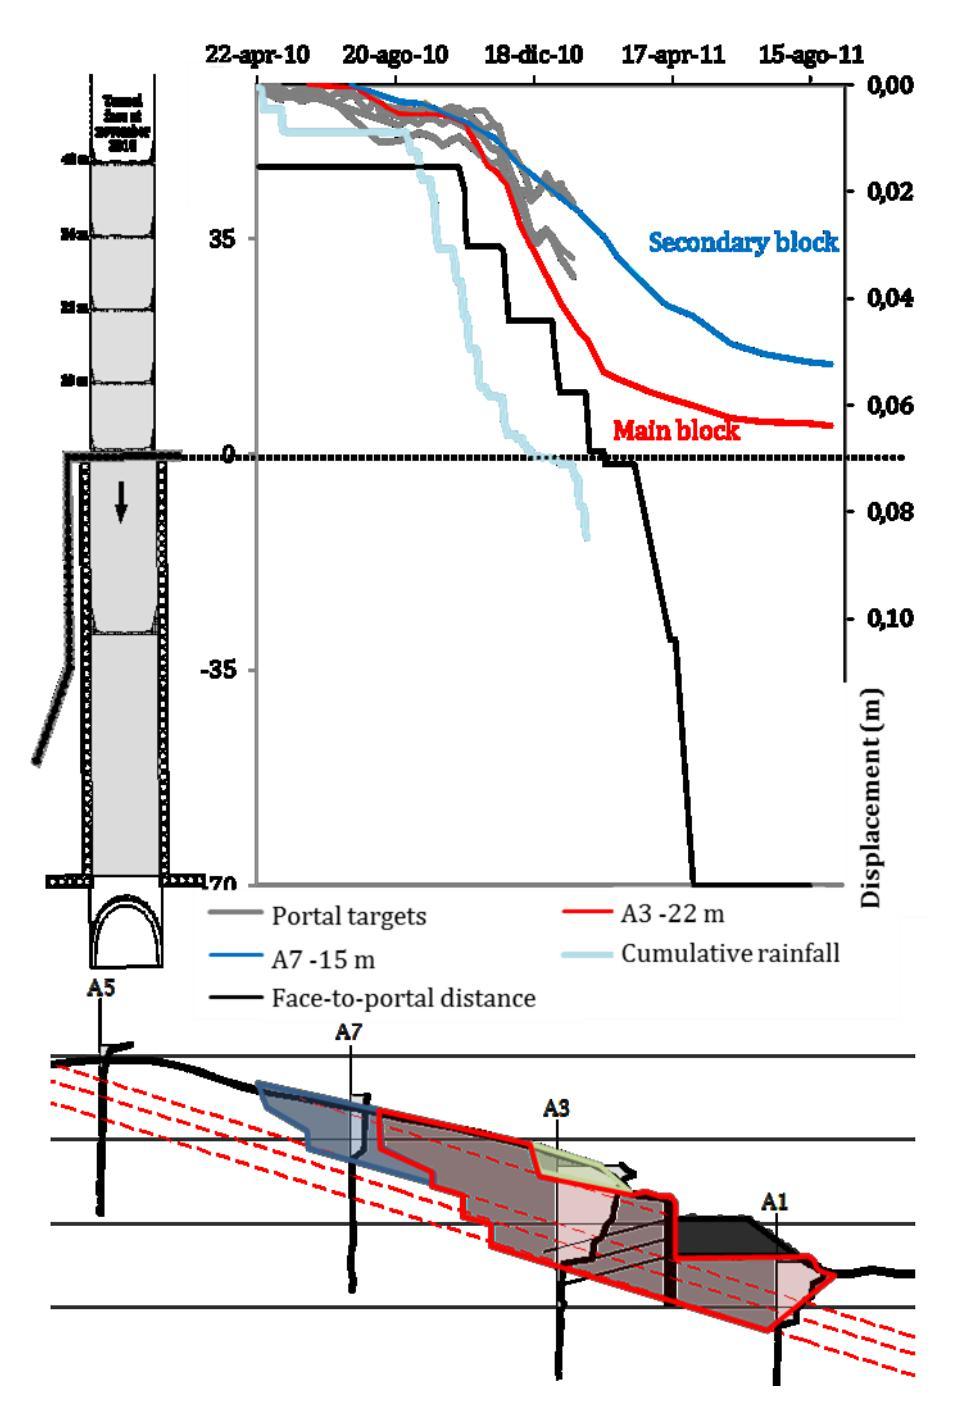
The movements of the two moving blocks, the primary and secondary, respectively, at depths of 22 m and 15 m deep, are shown in relation to different stages of progress of the tunnel face.

The block displacement speed is markedly reduced in the last tunnel excavation field due to the lower excavation induced stress relief; it gets close to zero after the completion of the artificial tunnel the occurrence of particularly intense rainfalls.

Figure 16 Comparison between portal target and deep inclinometer displacements vs southbound tunnel face-to-portal distance.

The solution adopted was to create a retaining portal to host the future tunnel exit (Milano method), fill the whole portal area in order to gain normal stress in the passive zone and only then proceed to tunnel excavation up to the portal structure and through the filling material.
