Studio di una frana in terreni strutturalmente complessi: interazione con le opere di imbocco di una galleria stradale *Curriculum: Ingegneria dei materiali, delle acque e dei terreni*

Abstract. During the construction of the south portal of the tunnel Baldaia I along the SS106 motorway in Calabria, unexpectedly large and continuous displacements of the earth retaining structures occurred leading to a precautionary suspension of the excavation works. To study the kinematics of the observed instability phenomenon, inclinometer probes were used together with the topographic monitoring of the portal structures; it was found that the unstable mechanism was deep-seated, block-type and extending over the entire slope. In this paper the site investigation activities carried out to understand the origin of the instability process are presented. The interpretation of the observed behaviour is then given together with the description of the remedial measures suggested to safely complete the construction of the tunnel. The link between the time evolution of the instability and the sequence of the excavation works, which turned out to be an important issue in the process, is also discussed in

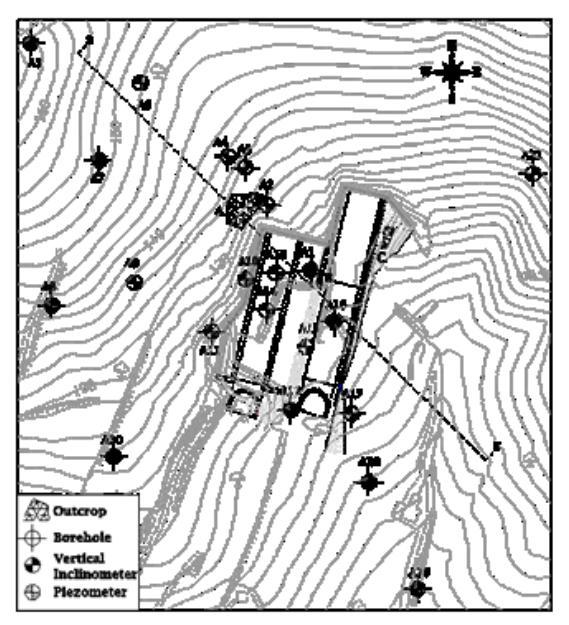
Figure 1 Investigated area and location of the boreholes and of the instruments.

The planned retaining structure consists of a multi-anchored "reverse W"-shaped wall connecting the two tunnel portals, which are longitudinally displaced about 30 m (see plan view of Figure 1). The tunnel direction is N-S so that the west wall wing is the most exposed to the effects of slope instabilities. The wall consists of 98 large diameter (D = 1200 mm) reinforced concrete piles, spaced at 1500 mm, retained with three levels of temporary anchors, 26 to 31 m long.

The landslide evolution has been followed through an extensive monitoring network (Fig. 1) which needed to be progressively updated during the construction works because of the frequent loss of instruments and the widening of the investigated area. The monitoring provided from the beginning of the excavation works (September 2007) for the retaining portal structures is a precision detection of the displacements of the top beam through in-place optical targets. When the first unexpected displacements occurred, a set of three boreholes were drilled along the slope in alignment with the dipping direction, up to a depth varying between 30.0 and 52.0 m from the ground level and instrumented with inclinometer tubes. The results of such monitoring showed the presence of a planar, block type, sliding surface at about 20 m from the surface. Since April 2010, a new site investigation was initiated to highlight the kinematics and the time evolution of the observed landslide phenomenon.

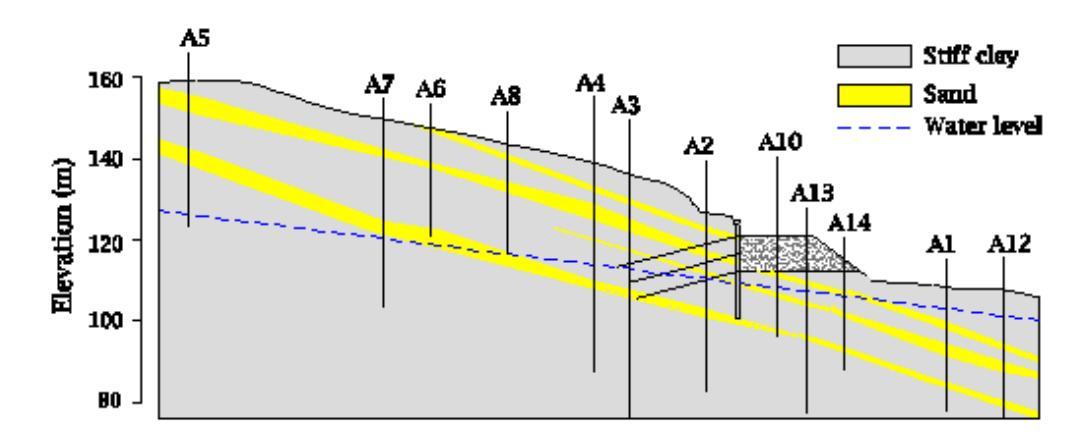
The soil stratigraphy is well represented by a typical borehole log in Fig. 4; within the investigated depth of 45 m it appears characterized by the diffuse presence of the overconsolidated clay formation that is however interlaid by three sandy layers which were recovered at depths of 3, 10 and 32 meters from the top. CPTu profiles are also shown in Fig. 4. These profiles are very useful to detect shear planes, through a drop of both the point resistance and of the driving induced pore water pressure increment. Despite the lenticular nature of the depositional environment, the interlaid sandy layers appeared continuous at the slope scale (Fig. 5).

Figure 5 Location of the boreholes for slope stratigraphy.

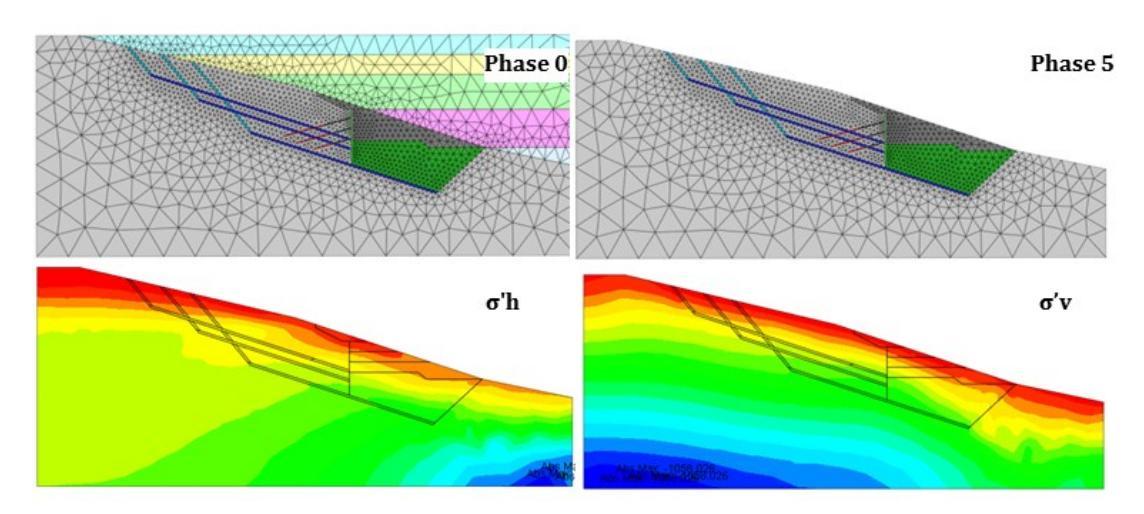
The initial stress of the slope, characterized by overconsolidated clays, was achieved through a preload obtained by filling the ground to the crest and then removing the exceeding soil by means of five excavation steps (Fig. 12).

Figure 12. Simulation of the phases of erosion; horizontal and vertical in situ effective stresses
